RE: New Mexico Water Service Company; Rio Del Oro Wastewater Treatment Facility; Minor Facility; NPDES Permit No. NM0030414; NPDES Compliance Evaluation Inspection; June 4, 2019

RIO DEL ORO WWTP COMPLIANCE EVALUATION INSPECTION NPDES Permit No. NM0030414 June 4, 2019

New Mexico Water Service Company / Rio del Oro Membrane Bioreactor Treatment Facility

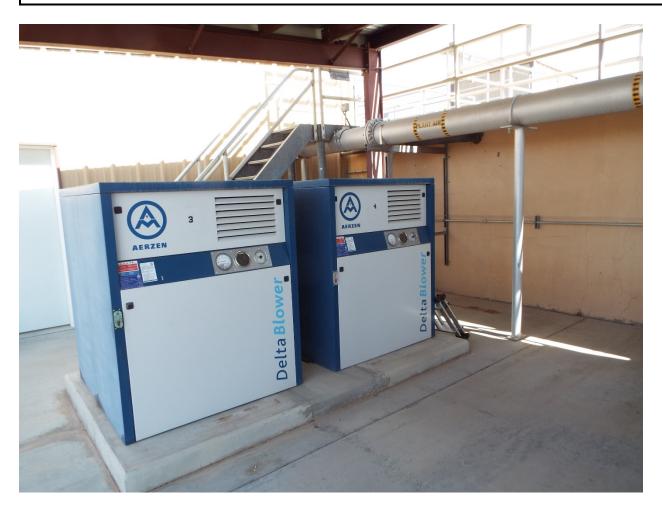
Location: Rio Del Oro

Subject: New Aerzen Blowers (2)

Air is supplied to the pre-aeration and bioreactor basins with two (2) separate aeration systems. Two (2) aeration blowers are provided for each system (one on line; one standby). The MBR is monitored and controlled by a programmable logic controller (PCL) that also provided supervisory control and data acquisition for alarm notification. Operator control is provided through a human-machine interface that is simply a PC located in the admin/lab building. In the event of a failure of the PLC, the facility can also be operated manually.

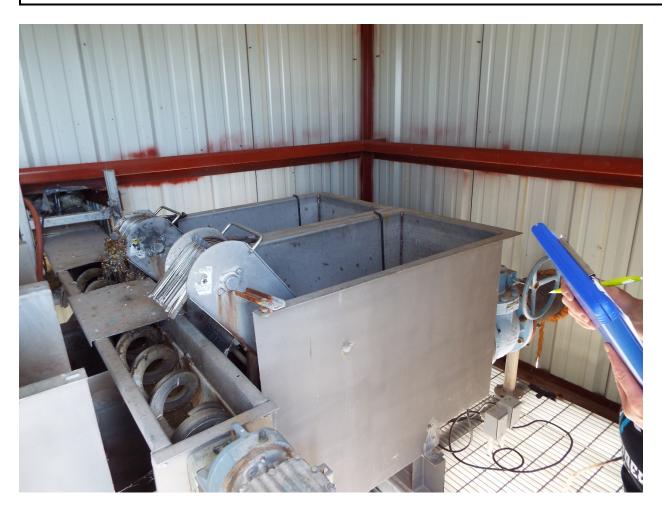
Location: Rio Del Oro

Subject: Headworks with stainless steel bar screen

Raw sewage is discharged into one of two (2) automatic fine bar screens (one on-line; one standby) that are provided with a common conveyor/washer/compactor (CWC). The CWC removes organics from the screenings and automatically dumps the washed and compacted screenings into a dumpster that is emptied at a landfill.

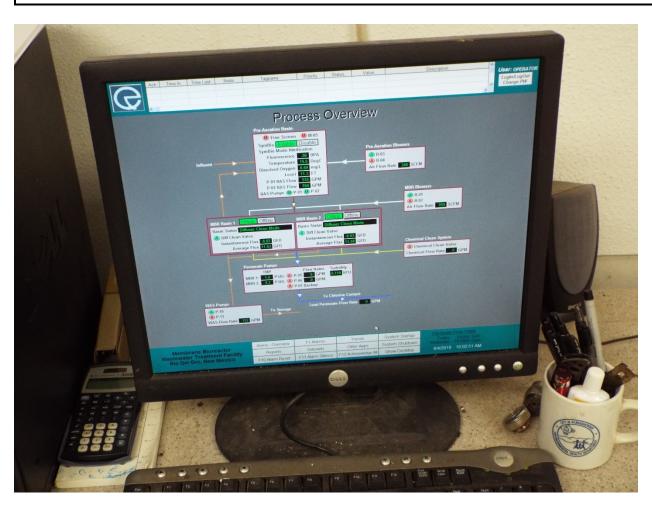
Location: Rio Del Oro

Subject: Computer screen with overview of plant. New Computer will be installed in the next week.

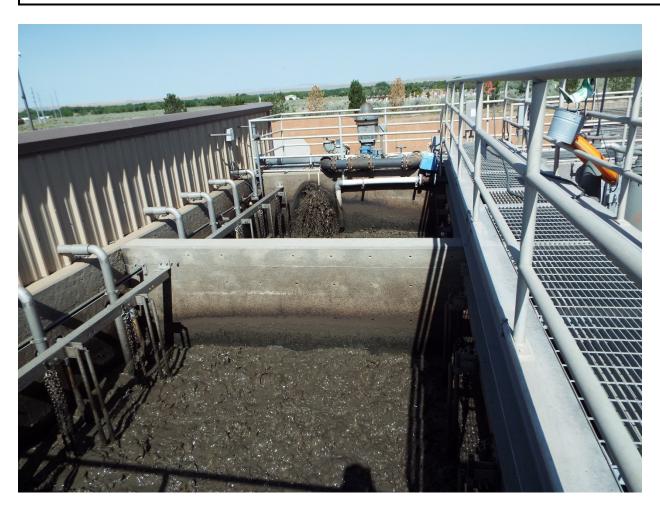
Location: Rio Del Oro

Subject: Membrane Bioreactor basins

Two (2) submersible pumps continuously pump the mixed liquor from the pre-aeration basin into each of the two (2) separate bioreactors. Each reactor is equipped with four (4) submerged membrane units (SM*) which have 200 flat plate filters in each unit. Facility effluent is withdrawn through the flat plate

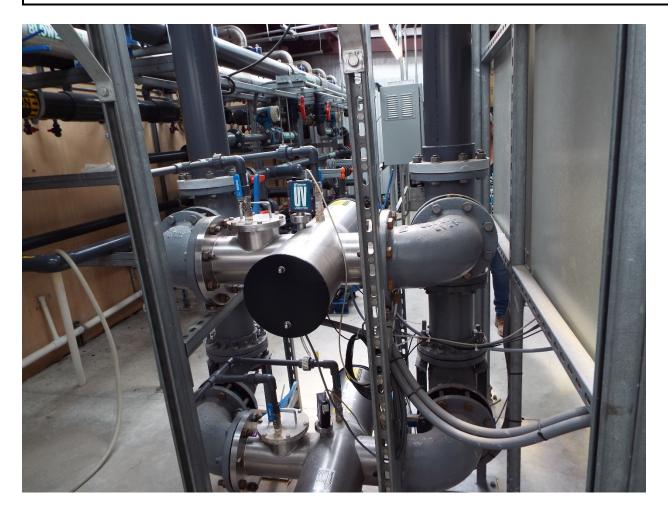
Location: Rio Del Oro

Subject: UV System

membranes (filtered) by permeate pumps (two in line; one standby), disinfected with ultraviolet light, and discharged to a holding basin for irrigation reuse.
